Manhole Inspection Summary

Manhole # S15Y__010MH

Insp Date: **6/25/08 8:26 AM**

Location Address: **2613 georgetown rd**

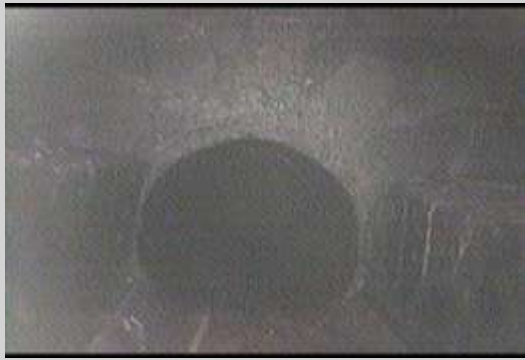
12 O'Clock Outflow

8 in. Circular Gravity Sewer
Pipe Out @ 12 O'Clock

Pipe Height: **8.4** (in.) Rod and Bar (Angled)
Pipe Material: **Clay** ☐ Pipe Lined
Invert Depth: **6.82** (ft.) Flow Characteristics: **Slow**
Deposits: ☒ None ☐ Mud ☐ ~~Gravy~~ ☐ Debris ☐ Grease
Silt Depth: **0** (in.) Deposits Extent:
Infiltration: **None** Pipe Seal Cond: **Sound**
